SALMONID HABITAT LIMITING FACTORS WATER RESOURCE INVENTORY AREAS 15 (WEST), KITSAP BASIN AND 14 (NORTH), KENNEDY-GOLDSBOROUGH BASIN

**FINAL REPORT
JUNE 2003**

Michael Kuttel, Jr.
Washington State Conservation Commission
P.O. Box 47721
Olympia, WA 98503

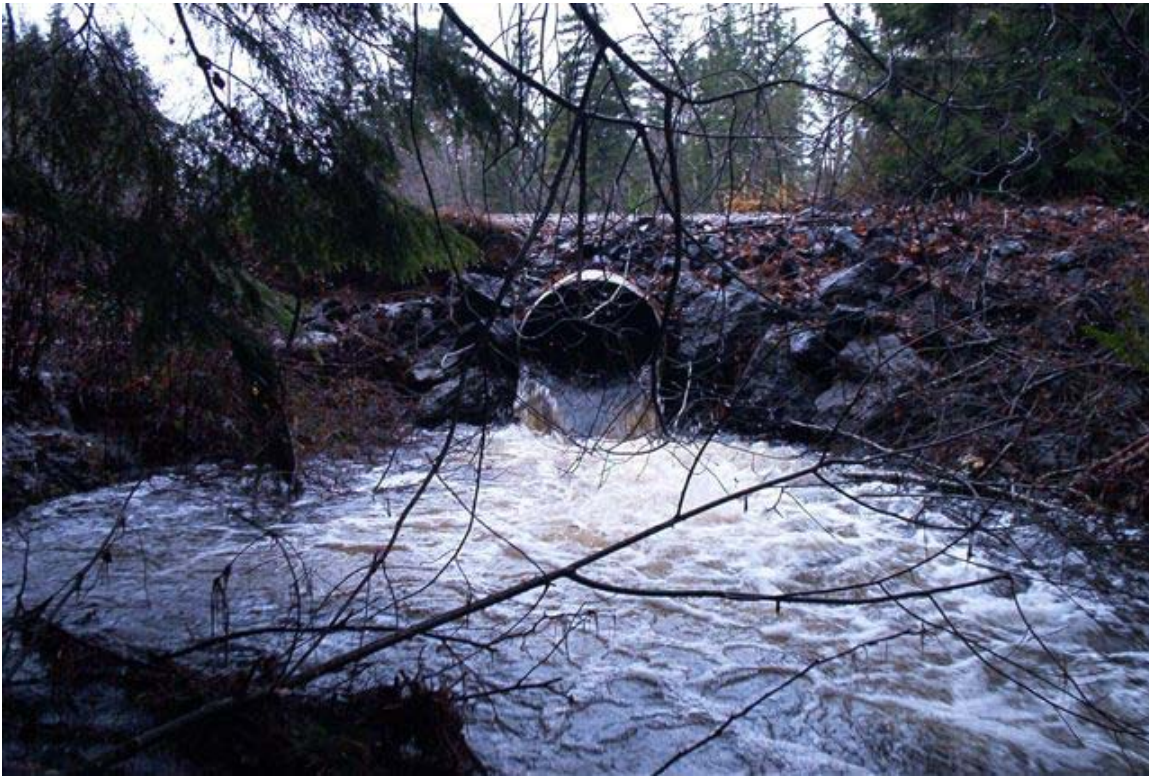
Figure 1. Culvert near RM 1.0 on Windship Creek (15.0436), left bank tributary at RM 7.7 of the Dewatto River. This culvert is a partial barrier to adult and juvenile salmonids. Beaver ponds upstream provide quality salmonid rearing habitat. Photo courtesy of Marty Ereth, Skokomish Tribe.

Artificial obstructions can block salmonid migration up and down streams. Depending on the location and longevity of the barrier, the negative effect may be limited to a portion of only one generation, or in extreme cases, the barrier may cause the extirpation ^{def.} of an entire run of fish. Man-made structures that may hinder salmonid migration in west WRIA 15 and north WRIA 14 include dams and failed culverts. Natural waterfalls and cascades are common in headwater areas (Figure 1).

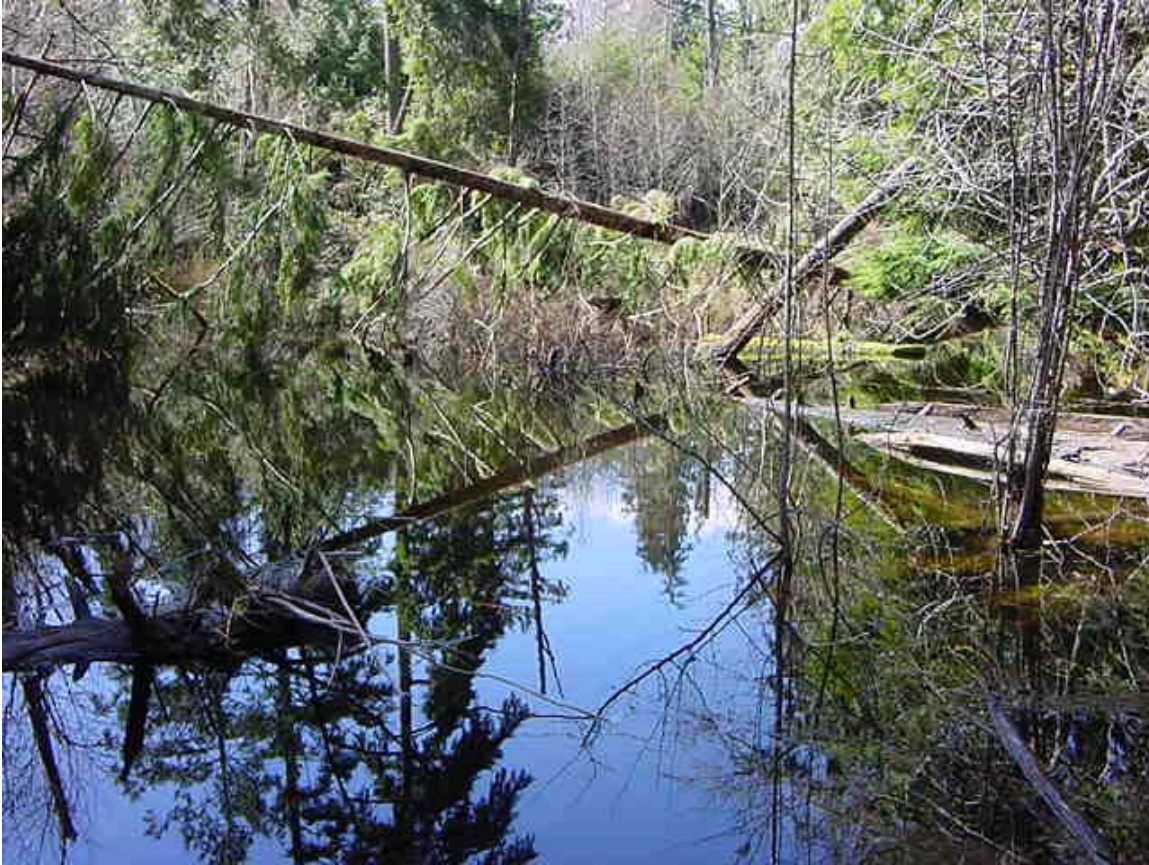
Figure 2. Beaver pond in the Sherwood Creek Watershed (outside the report are in south WRIA 14). Beaver ponds provide excellent rearing habitat for coho salmon and cutthroat trout. Abundant woody debris provides cover, while the pond provides shelter from low summer and high winter flows. Photo courtesy of the Allyn Salmon Enhancement Group.

and/or woody cover, allowing juvenile salmonids to hide from predators and conserve energy (Sandercock 1998). Diking, and channelization of rivers, conversion of riparian zones to pasture and cropland, floodplain development, and extermination of beaver all play a roll in destruction of off-channel habitat (Figure 2).

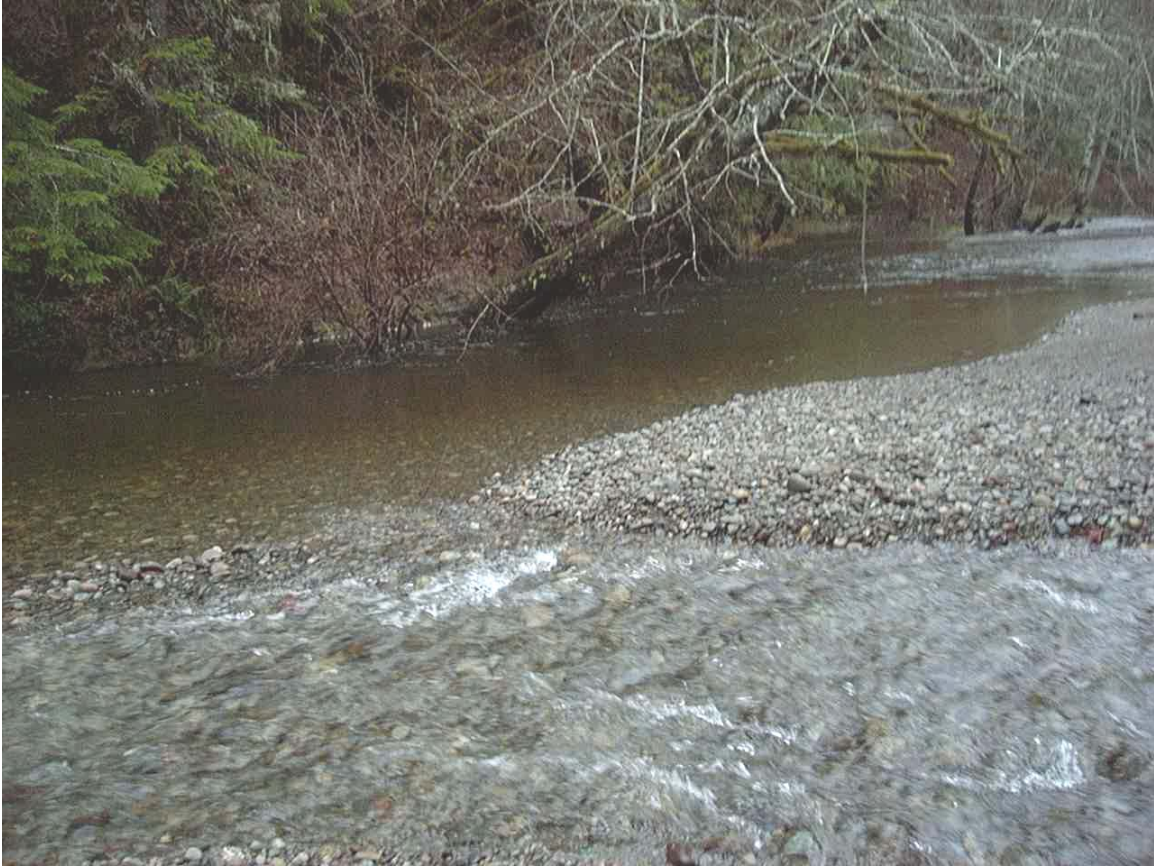
Figure 3. Clean gravel at Port of Dewatto on Dewatto River, December 2002. Substrate at this site was very loose. Recent chum salmon spawning activity likely enhanced this condition. Photographed by the author.

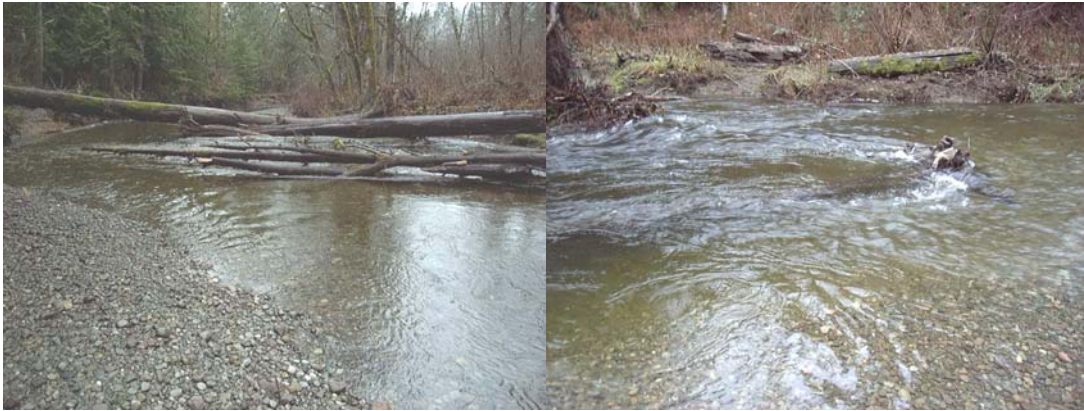
Figure 4. Large woody debris at Port of Dewatto on Dewatto River. The wood at left provides overhead cover, while the rootwad at the right has created a pool where fish can rest. The wood at left will be submerged during high water, providing shelter from high flows. Photographed December 2002.

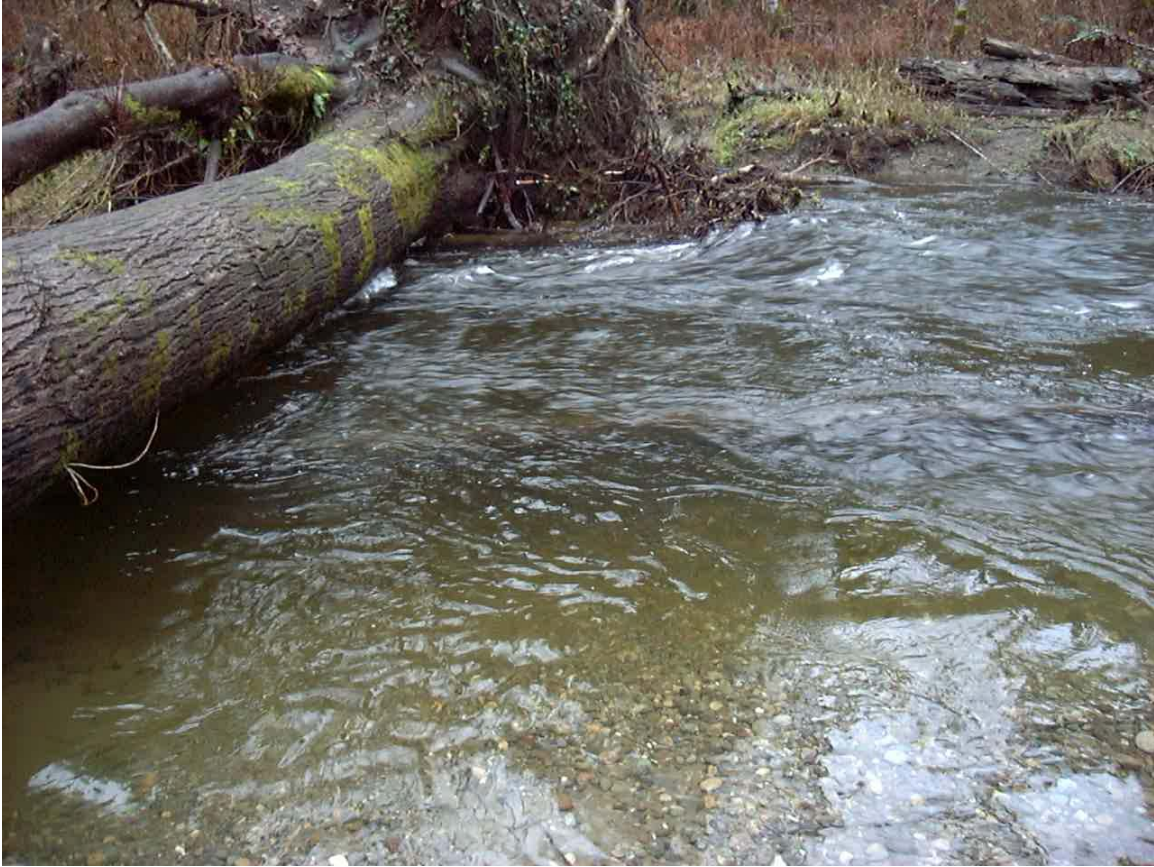
Figure 5. Pool at Port of Dewatto on Dewatto River, December 2002. Large woody debris provides both overhead and submerged cover. Water depth and cover in this pool would provide suitable habitat for adult and juvenile salmonids. Photographed by the author.

Important features of pools are size, depth, and cover (both instream and overhead). Generally speaking, the more size, depth, and cover that are present, the higher the quality of the pool. Large-deep pools with lots of cover provide many hiding areas, ample forage, and cool water temperatures. An abundance of pools interspersed with riffles combine to create ideal salmonid habitat (Figure 5).

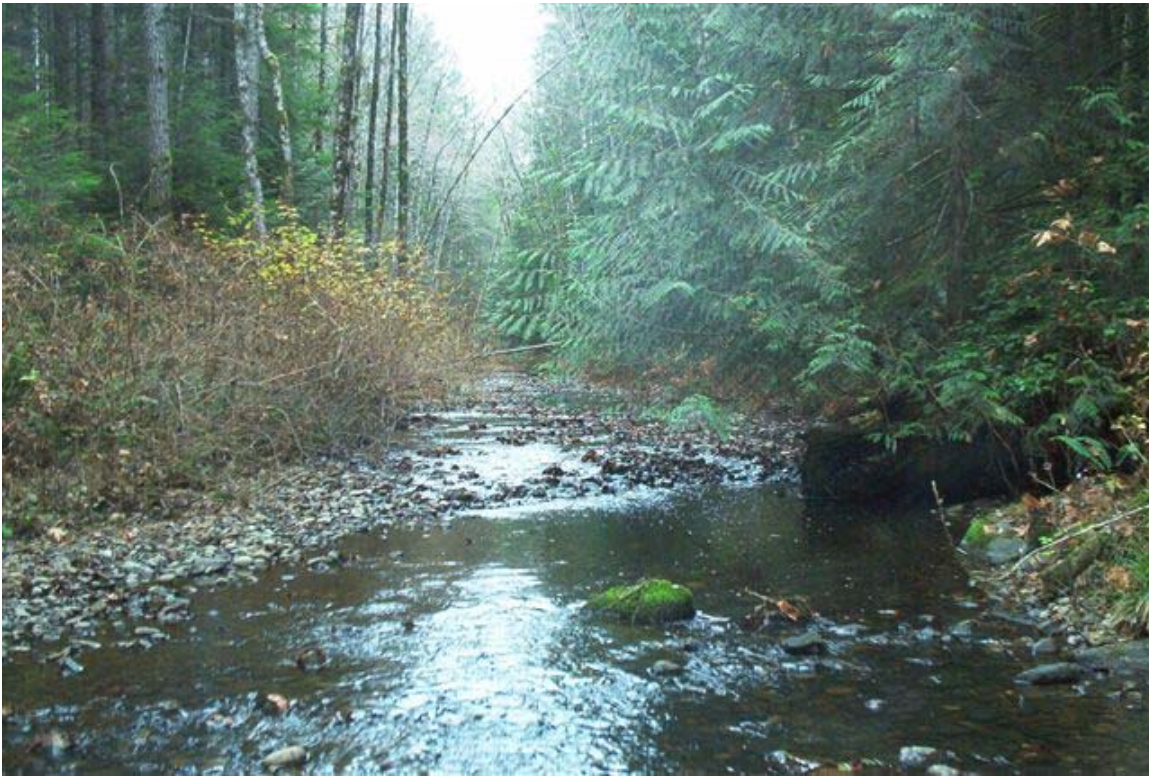
Figure 6. Upper Tahuya River downstream from Tahuya Lake, early December 2002. Shrubs and trees in the riparian zone stabilize streambanks. Photo courtesy of Marty Ereth, Skokomish Tribe.

Natural streambank stability maintains the integrity of riverine processes. The root masses of riparian vegetation and large woody debris stabilize streambanks (Figure 6). Riparian zones can maintain or repair themselves if they are located on a stable bank. Vegetation has a difficult time recovering from flood damages or other disturbances if it is continually undermined by a failing bank (Naiman *et al.* 2001). Stable streambanks also ensure an adequate channel depth. A given volume of water is deeper in a narrow channel than in a wide channel. Depth maintains the cool temperatures and hiding cover needed by salmonids. Rapidly eroding banks tend to lead to development of overly wide and shallow channels (Platts 1991). Eroding streambanks can contribute large amounts of fine sediment to the water column as well as large amounts of coarse sediment that is deposited in the stream channel (aggraded), thus leading to subsurface flows (Hicks *et al.* 1991, Ziemer and Lisle 2001). Fine sediment appears to have little negative effect on adult salmonids (unless levels are chronically high), but it smothers developing juvenile salmonids buried in the streambed and fills interstices between gravels, cobbles, and boulders that provide important winter cover (Bjornn and Reiser 1991) (See [Fine Sediment](#)).

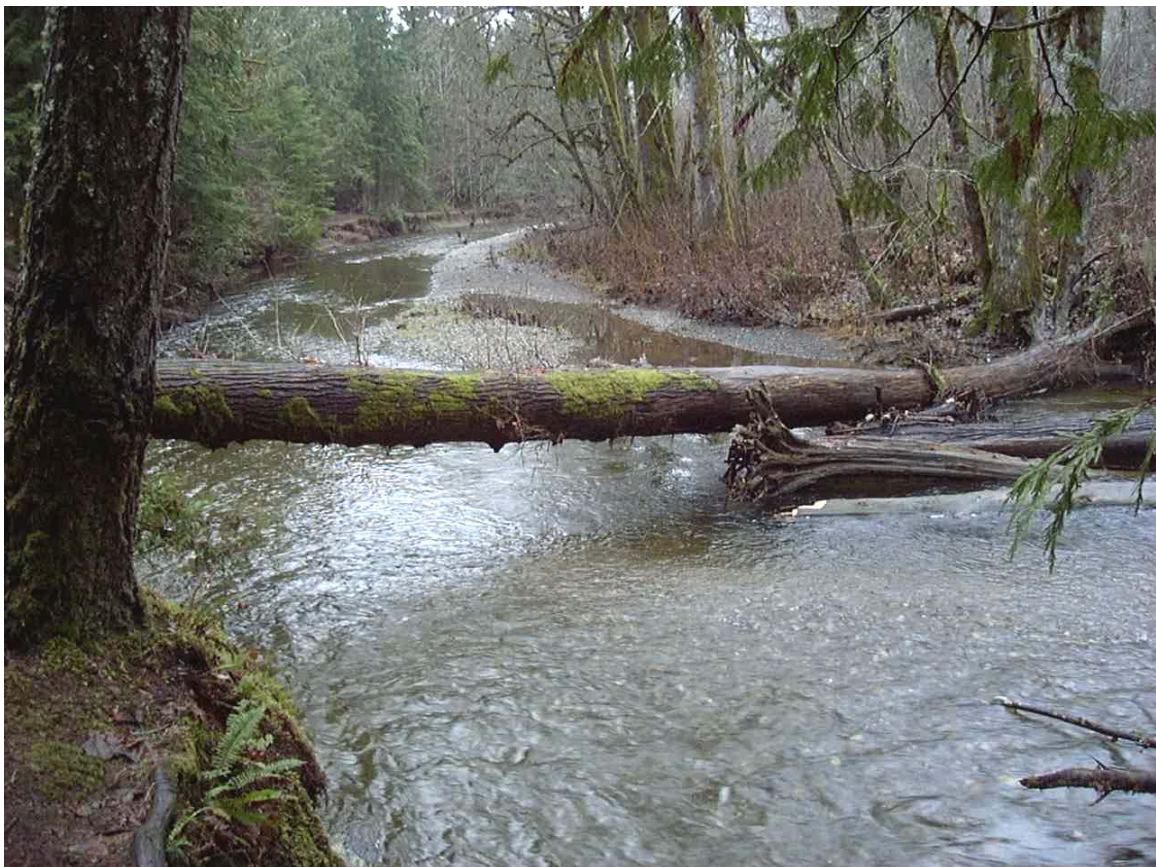
Figure 7. Riparian vegetation at Port of Dewatto on Dewatto River, December 2002. Shrubs and trees stabilize streambanks and provide shade to maintain cool water temperatures. Also note the large woody debris recruited from mature trees in the riparian zone. Photographed by the author.

developing in streambed gravels) (Bjornn and Reiser 1991). Overhanging tree canopies shade water (Naiman *et al.* 2001), maintaining the cool temperatures salmonids need to thrive (Bjornn and Reiser 1991). Leaf litter falling into the stream is an important component of primary production within the aquatic community (Bisson and Bilby 2001), although Murphy (2001) asserts that aquatic plants and algae make a larger contribution. Microinvertebrates (i.e. zooplankton) and macroinvertebrates (larval insects, aquatic snails, etc.) feed on the decomposing organic material. Fish and other animals in turn feed on the smaller organisms (Bisson and Bilby 2001). Mature trees in the riparian zone also provide important function when they are knocked into streams by floods, windthrow, or landslides. These woody materials are known as large woody debris (LWD). Large woody debris stabilizes streambeds and banks, captures spawning gravels, encourages pool formation, provides resting and hiding cover for salmonids, and creates habitat for insects and other forage important to salmonids (Bilby and Bisson 2001). Finally vegetation within the riparian zone filters soil and pollutants from stormwater runoff (Knutson and Naef 1997, Welch *et al.* 2001) and reduces flood damage by slowing down flood waters, thereby dissipating energy and capturing soil carried in the flood waters (Naiman *et al.* 2001) (Figure 7).

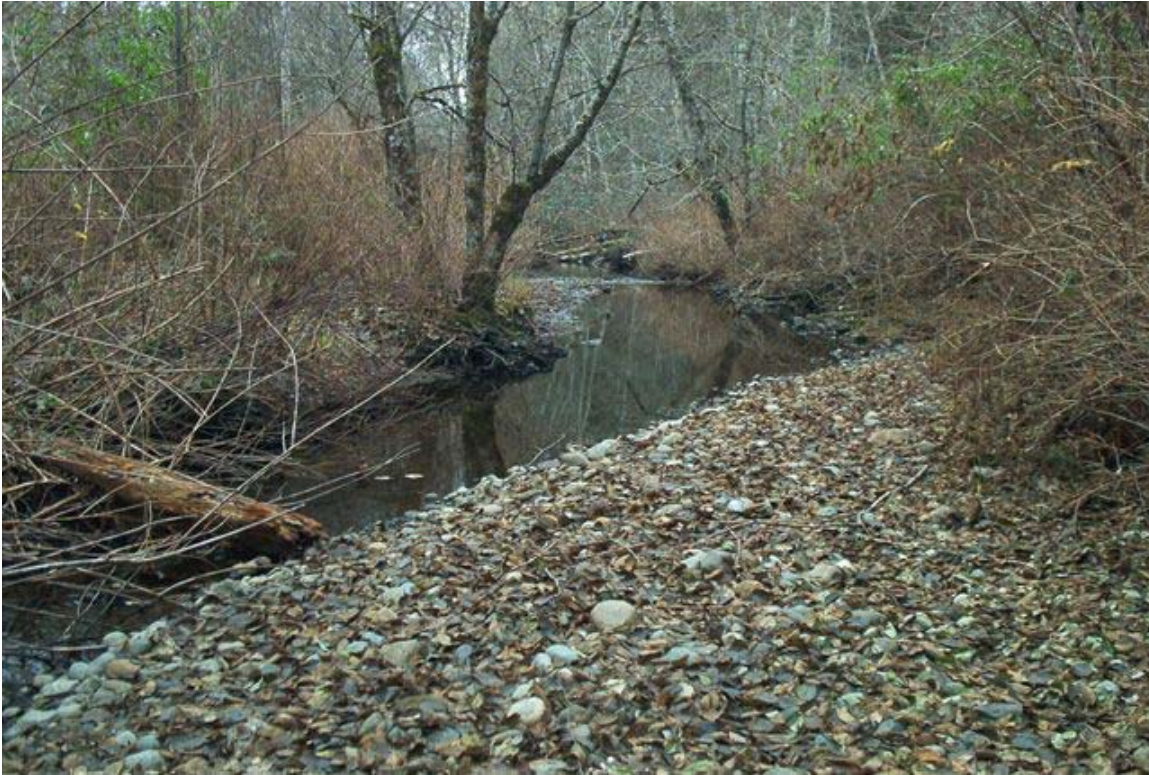
Figure 8. Upper Tahuya River below Tahuya Lake, early December 2002. Stream flows were still low at the time since the winter rains had not arrived. During the dry season, groundwater and wetlands provide the majority of flow to streams within the report area. Photograph courtesy of Marty Ereth, Skokomish Tribe.

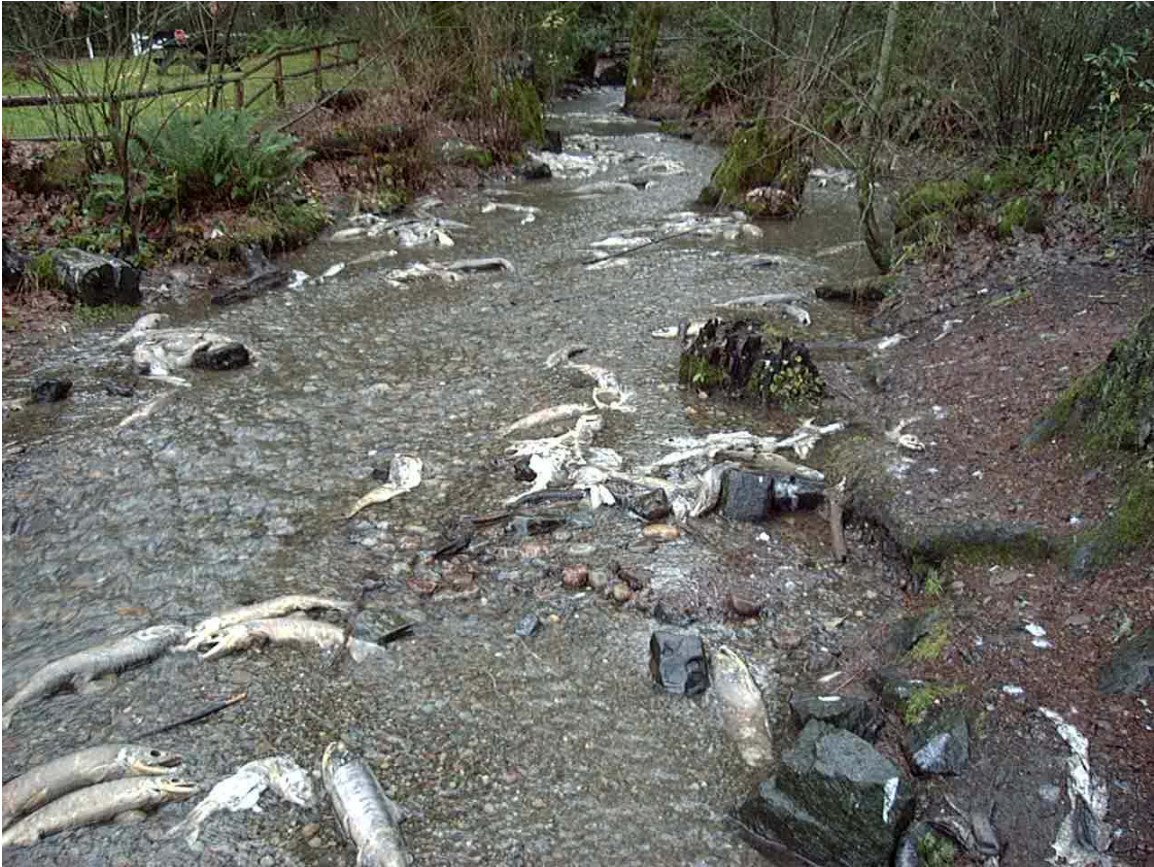
Figure 9. Chum salmon carcasses at the mouth of Twanoh Creek, December 2002. Decaying carcasses from spawned-out salmon provide ocean-derived nutrients that benefit many organisms in Pacific Northwest watersheds. Photographed by the author.

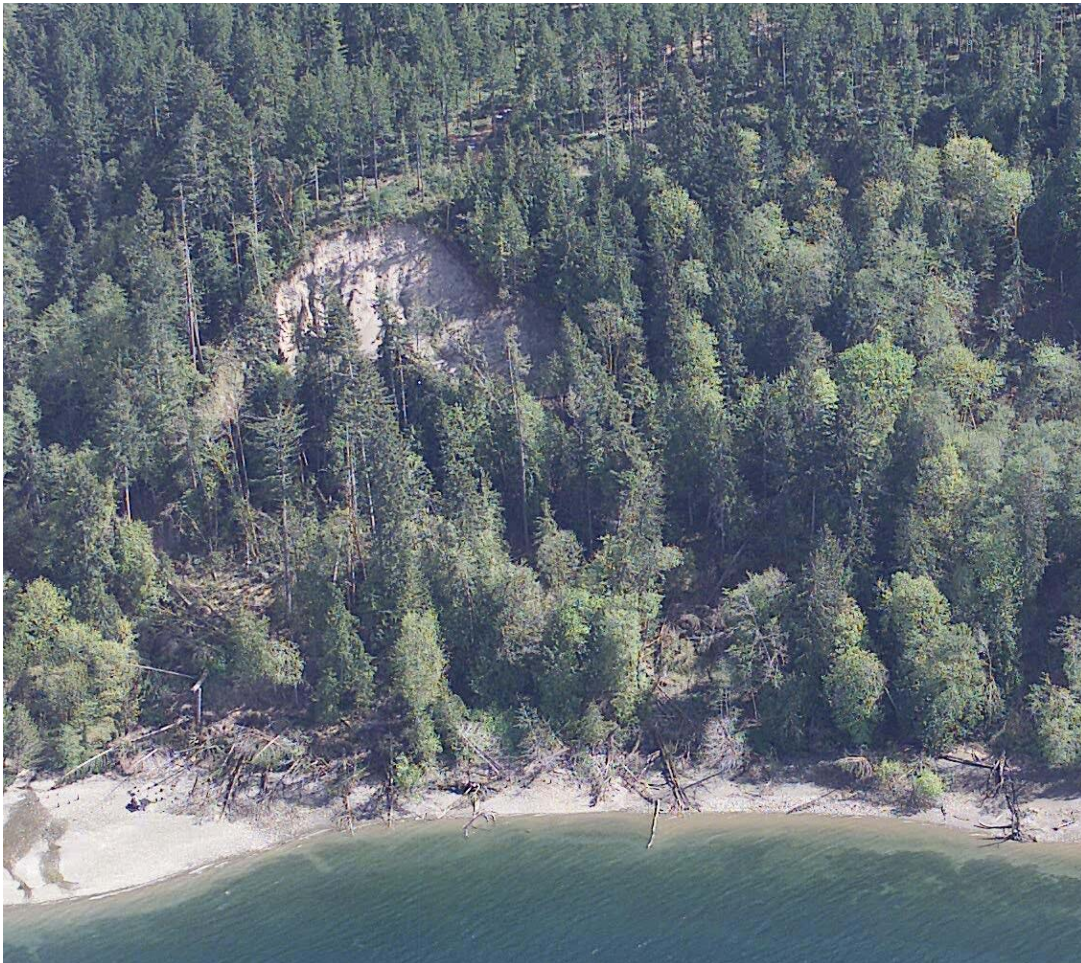
Figure 10. Eroding bluff just north of the mouth of Harding Creek. Eroding bluffs provide sediment and large woody debris critical to maintenance of shoreline landforms along Hood Canal. Ecology oblique aerial photo number 010426-151428 (Washington Department of Ecology 2000b).

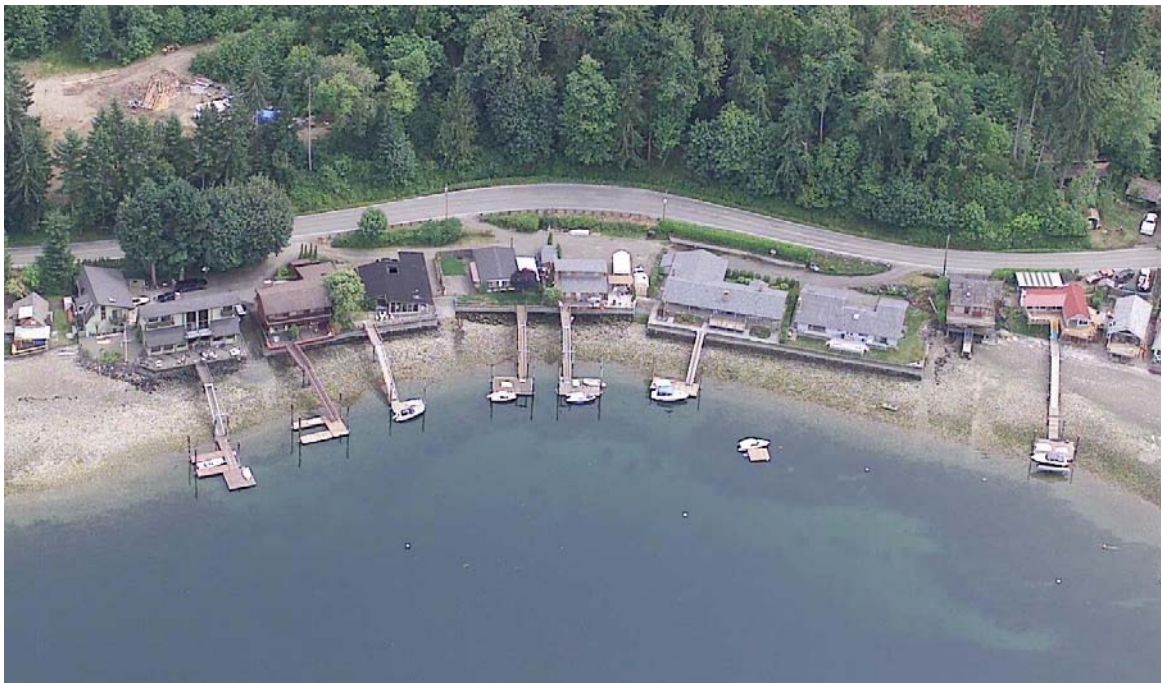
Figure 11. Each residence along Hood Canal often has its own pier and dock. These homes are along SR 106 on the east arm of Hood Canal. Photo number 010626-151838 (Washington Department of Ecology 2000b).

The shoreline of Hood Canal is a popular site for residential development. In particular, the north and south shores of the east arm of the canal have been extensively developed for residential use (Yoshinaka and Ellifrit 1973, Brody 1991, Washington Department of Ecology 2000b). Docks limit, or eliminate eelgrass beds through shading and the physical structures of the docks themselves. They can also alter juvenile salmonid behavior, forcing fish from the shallows into deeper water where they are more vulnerable to predation (Simenstad 2000). Many of the docks on lower Hood Canal are large, exceeding 400 square-feet, to compensate for small residential lot size (Small 2003, Personal communication). Naturally, docks and piers are often accompanied by boats. Propeller scour from boats can damage benthic communities and remove eelgrass (Simenstad 2000). Individual residences frequently have a private pier and/or dock. In many cases the water craft in use at these docks are small enough to store on land and trailer to a public boat launch (TAG 2003). See Figure 11.

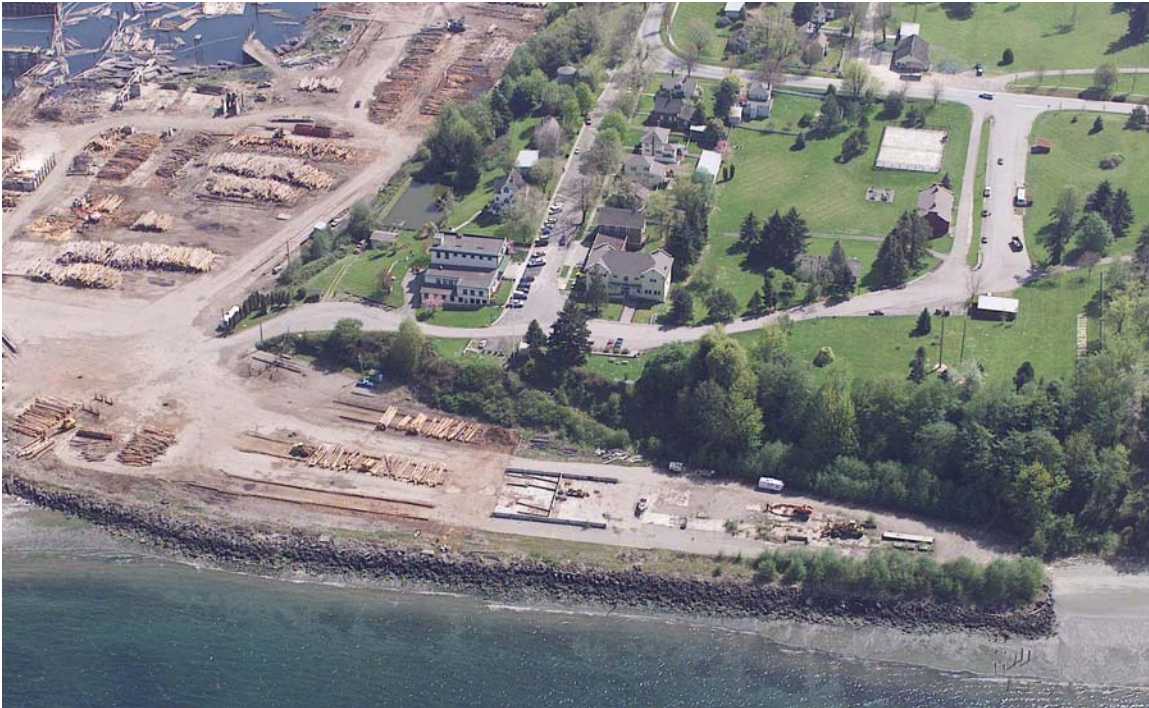
Figure 12. Port Gamble Log Mill and the community of Port Gamble. Impervious surfaces and lawns likely contribute pollutants to Hood Canal. Port Gamble is one of the few communities in the report area with a sewage treatment plant, which should minimize wastewater impacts. Ecology oblique photo number 010426-144112 (Washington Department of Ecology 2000b).

flow over the ground surface. Stormwater runoff is often contaminated with soil and pollutants including oil and antifreeze from cars and fertilizer, herbicides, and pesticides from lawns. See Figure 12.

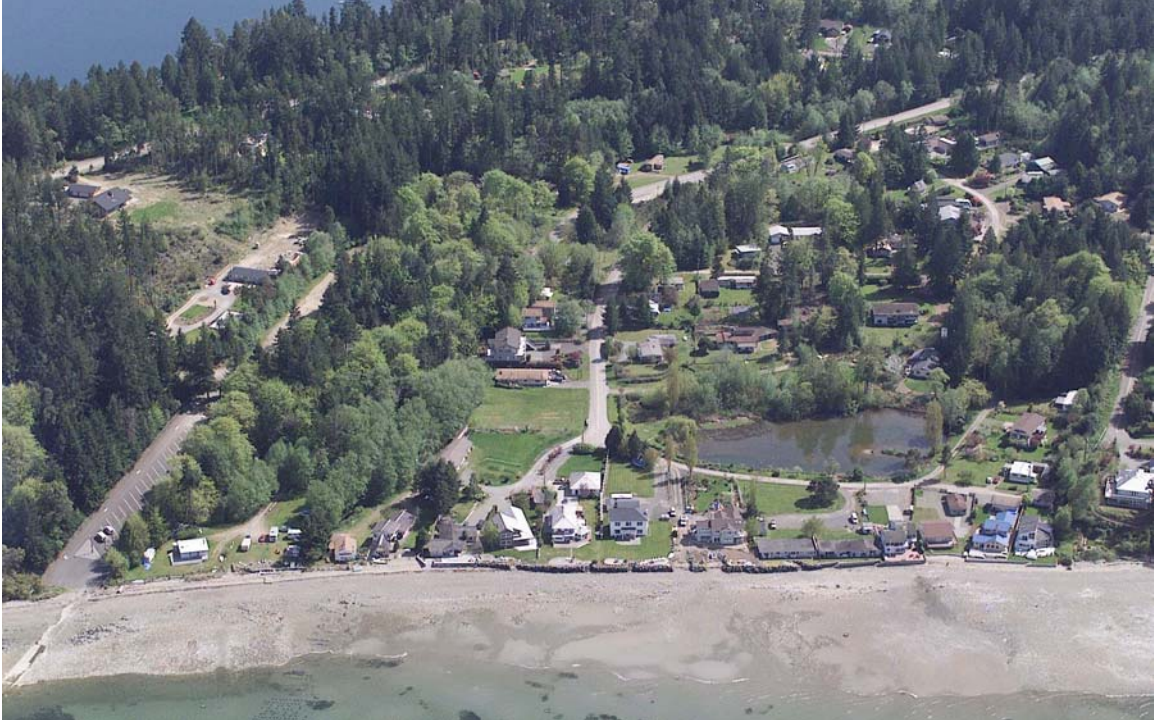
Figure 13. The present site of the Miami Beach community was historically home to a spit, intertidal wetland, and four acre salt marsh. Ecology oblique photo number 010426-150222 (Washington Department of Ecology 2000b).

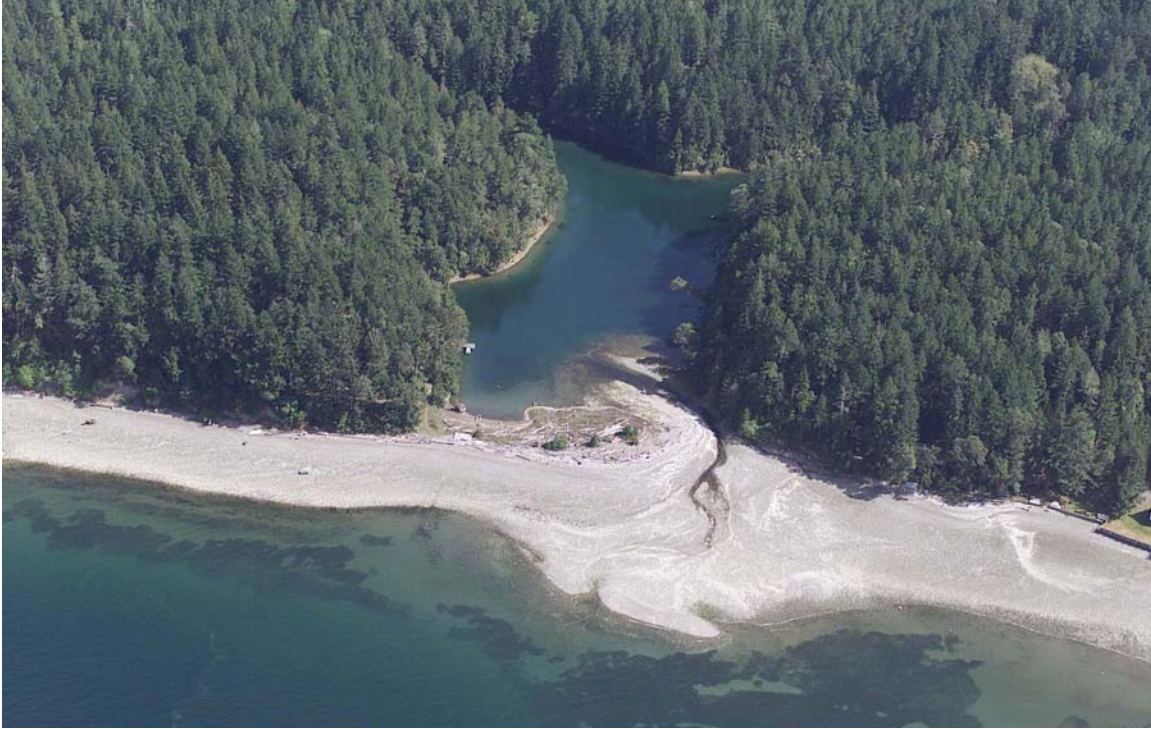
Figure 14. Mature coniferous riparian forest buffer at Spear-Fir Lagoon. Ecology oblique photo number 010426-150342 (Washington Department of Ecology 2000b).

Riparian vegetation stabilizes the shoreline along Hood Canal, provides large woody debris recruited through windfall and landslides, slows runoff, filters soil and pollutants from stormwater, and provides shade important to maintaining cool water temperatures. Removal of riparian vegetation reduces shade and large woody debris recruitment. This loss of shade and LWD leads to a reduced supply of terrestrial insects, epibenthic prey, and loss of forage fish spawning habitat (Simenstad 2000). See Figure 14.

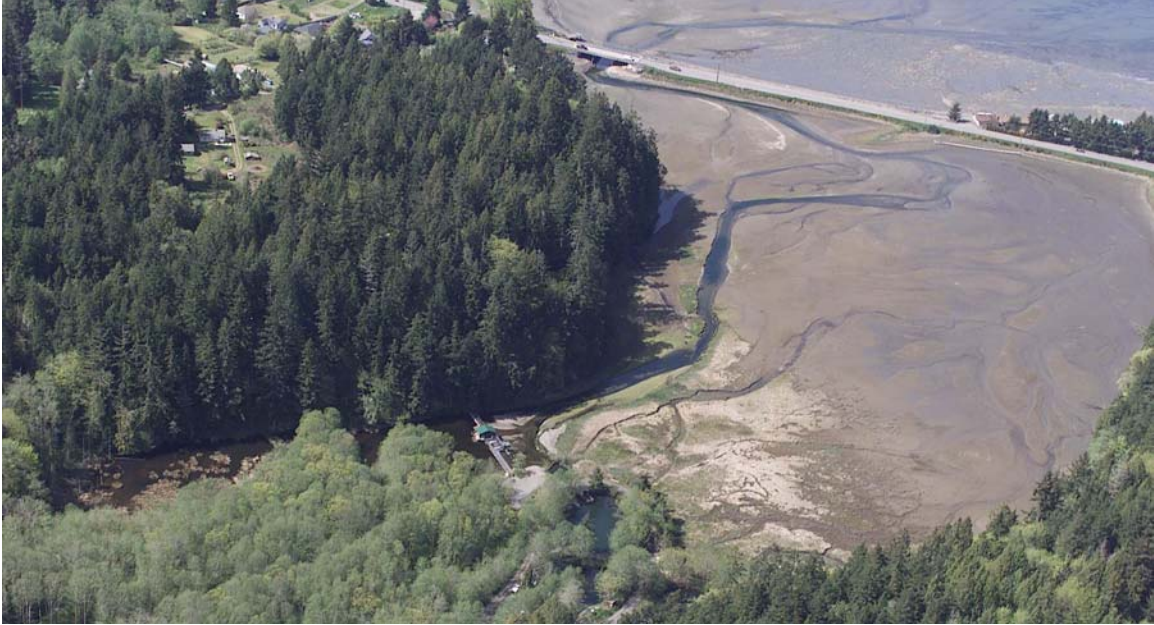
Figure 15. Tidal influence in Big Beef Harbor has been severely constrained by the Seabeck Highway. Ecology oblique photo number 010426-145346 (Washington Department of Ecology 2000b).
